MISCELLANEOUS PAPER GL-90-12

# CONDITION SURVEY AND PAVER IMPLEMENTATION, EDWARDS AIR FORCE BASE (SOUTH BASE), CALIFORNIA

Ross A. Bentsen

August 1990

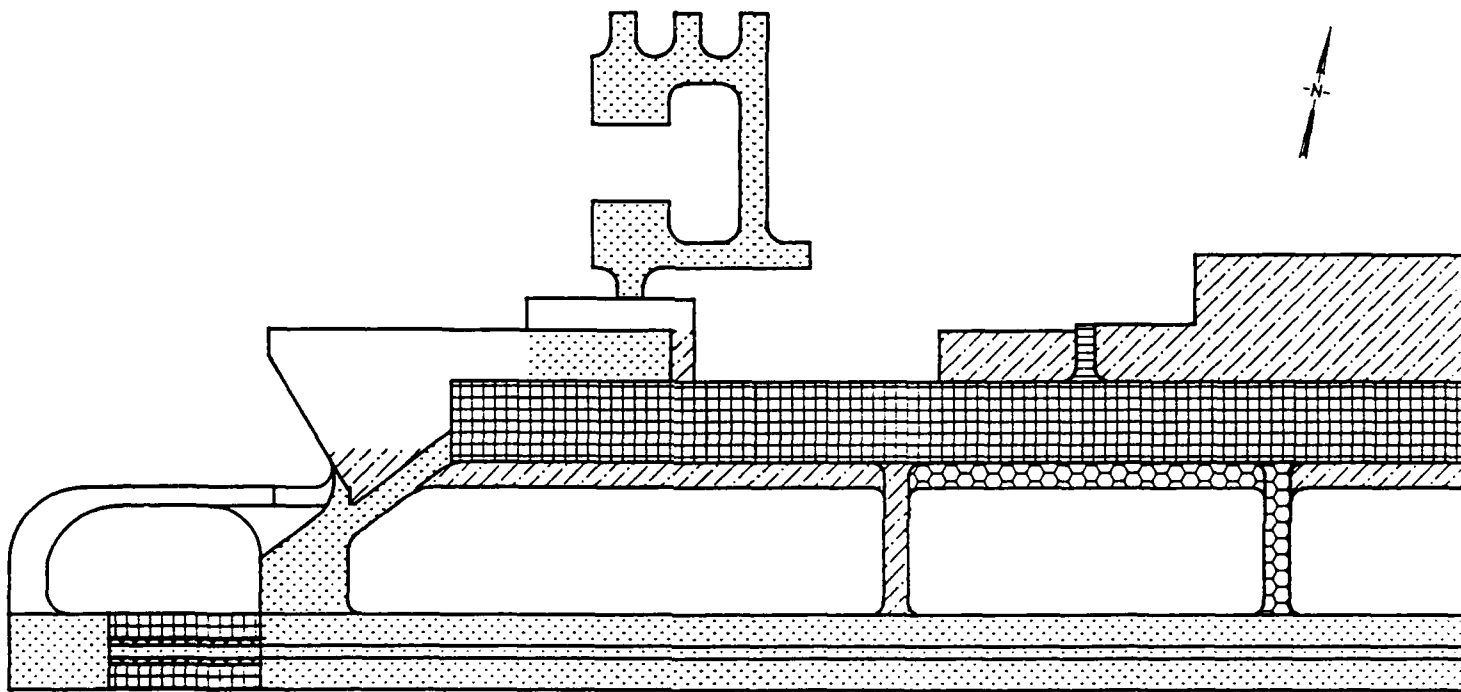
Figure 17. Pavement condition ratings of South B

13. The majority of the pavement features at South Base are rated from fair to very good condition with some features rated from poor to excellent. Figure 17 illustrates the condition ratings of the features at South Base. Features T1C, T2C, and T3C were not due to the construction of an ordinance road down the taxiway length. Section 2 of feature A3B is inside the B-2 test facility and was not surveyed due to its proximity to the security fence. Photos 1 through 14 show various distresses that were observed on the airfield pavements.
